# Manhole Inspection Summary

Manhole # S23II1023MH

**Location** Address: **1331 ROLAND HEIGHTS AVE** Cross Street: **BUCHANAN AVE**

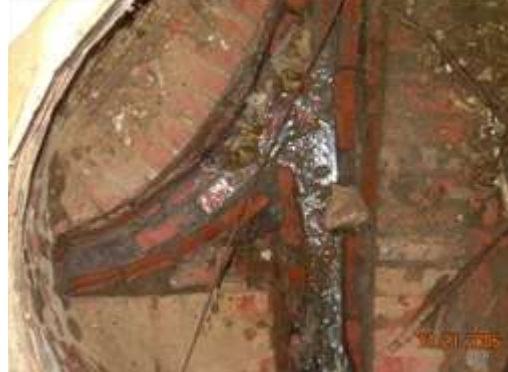
Top View

Bench and Channel debris.

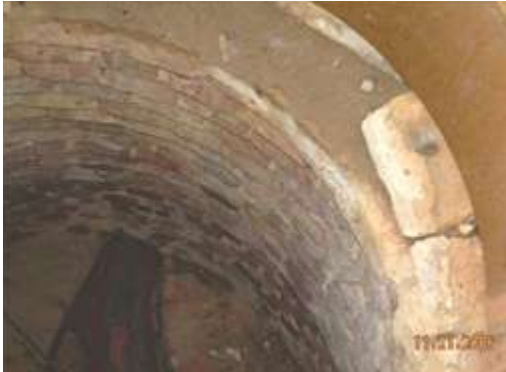
Defect

Frame leaks. Frame offset. Adjustment deterioration, loose brick, and infiltration. Corbel infiltration.

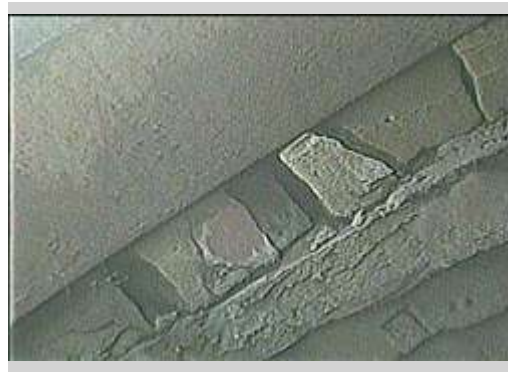
Defect

Frame leaks. Adjustment deterioration, loose brick, and infiltration.

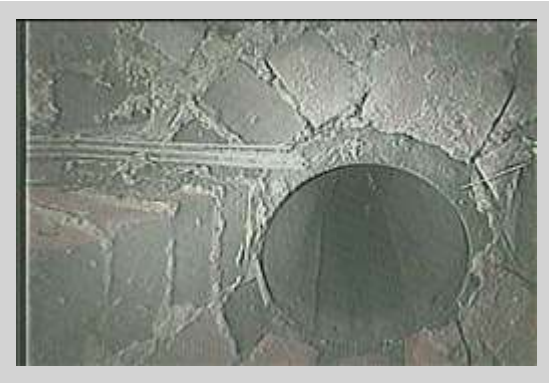
### 8 in. Circular Gravity Sewer Pipe Out @ 12 O'Clock

Infiltration: **Evidence** Pipe Seal Cond: **Unknown**

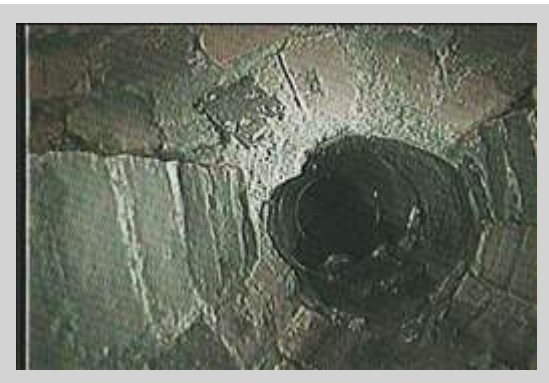
### 6 in. Circular Gravity Sewer Pipe In @ 6 O'Clock

Deposits: ☐ None ☒ **Mud** ☐ Sludge ☒ **Debris** ☐ Grease

Silt Depth: **0** (in.) Deposits Extent: **Light**

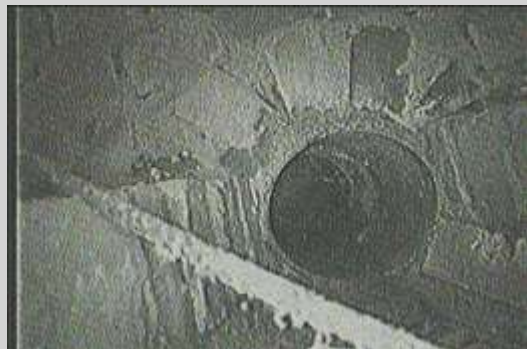
6 in. Circular Gravity Sewer

Infiltration: **Evidence**
